250 LIBERTYVILLE IL PEST,237 Peterson Rd.,Libertyville,IL,60048-1005,847-367-0100,630-834-9298

Servicing Branch	3250	Contract Number	P1013201
Customer	Kraft Chemical Company Kraft Chemical Company 750 OAKWOOD RD	Premise Number	1013201
	LAKE ZURICH	Visit Type	SERVICE MAINTENANCE
	IL	Visit Date	05/21/2024
	60047-1519

Order Number	Status	Service Date	Report Description
23822124		05/21/2024	PEST CONTROL MAINTENANCE

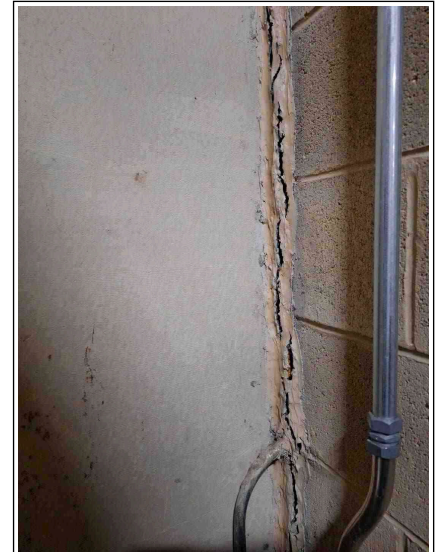
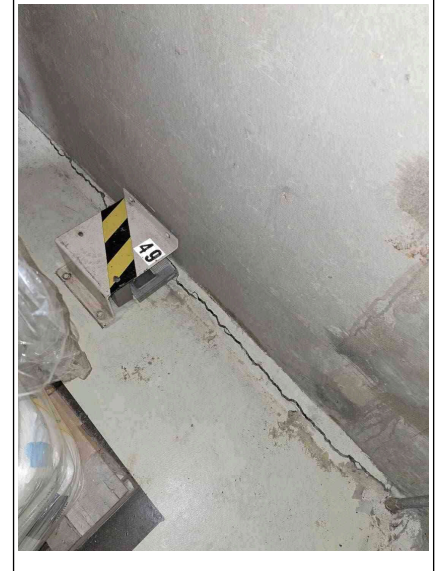
05/01/2024 Building: Building
Floor: Main
Reference: Zone: INTERIOR
21 Location Area: Internal
Location: INTERIOR
INSPECTION

Status:PENDING
Type: Structural
Responsibility:
Cracks or damage to wall allowing pest access. Please
repair to prevent pest entry.

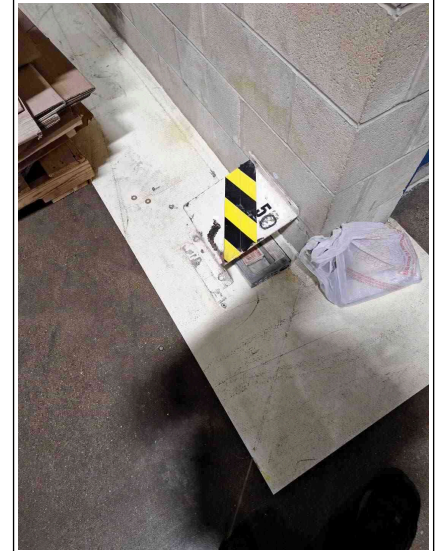
11/08/2023 Building: All Areas
Floor: All Floors Status:PENDING
Reference: Zone: Shipping / Receiving Type: Equipment
13 Location Area: Internal Responsibility:
hardhat is damaged and needs to be replaced

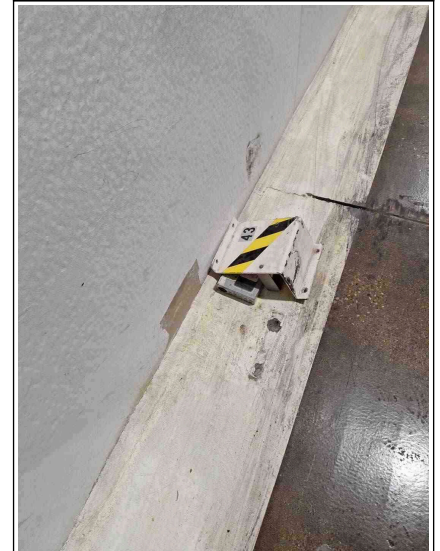
11/08/2023 Building: All Areas
Floor: All Floors Status:PENDING
Reference: Zone: Shipping / Receiving Type: Equipment
12 Location Area: Internal Responsibility:
hardhat is damaged and needs to be replaced

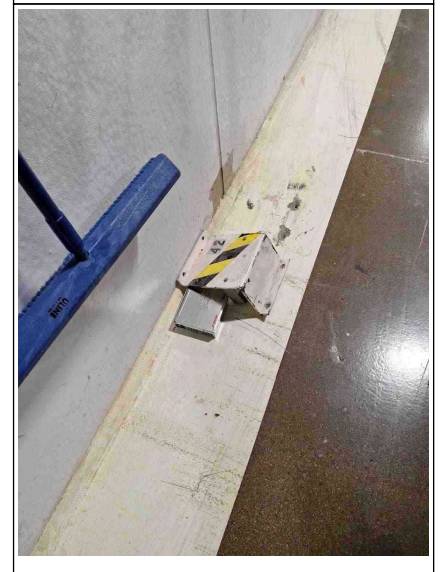
11/08/2023 Building: All Areas
Floor: All Floors Status:PENDING
Reference: Zone: Shipping / Receiving Type: Equipment
11 Location Area: Internal Responsibility:
hardhat is damaged and needs to be replaced.

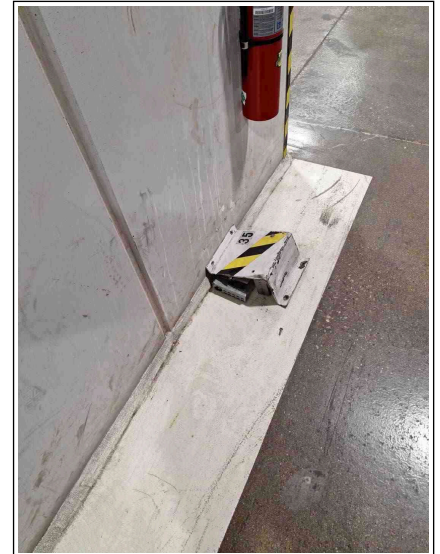
11/08/2023 Building: All Areas
Floor: All Floors
Reference: 10 Zone: Shipping / Receiving
Location Area: Internal
Location: MRT 035
Status:PENDING
Type: Equipment
Responsibility:
hardhat is damaged and needs to be replaced.

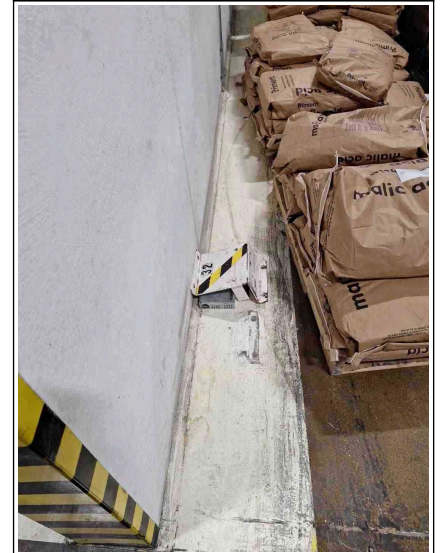
11/08/2023 Building: Building
Floor: Main
Reference: 9 Zone: Shipping/Receiving
Location Area: Internal
Location: MRT 032
Status:PENDING
Type: Equipment
Responsibility:
hardhat is damaged and needs to be replaced.

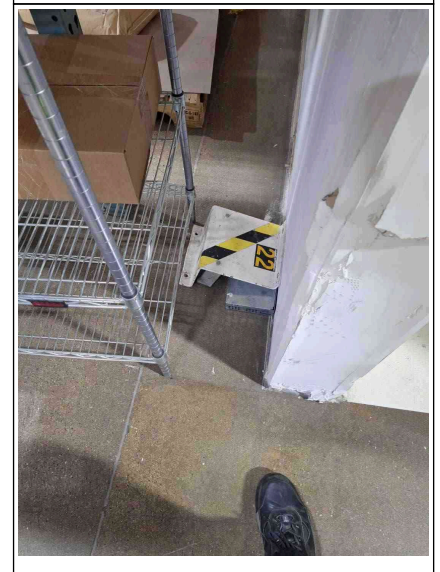
11/08/2023 Building: All Areas
Floor: All Floors
Reference: 8 Zone: Shipping / Receiving
Location Area: Internal
Location: MRT 022
Status:PENDING
Type: Equipment
Responsibility:
hard hat needs to be replaced
