056 ALBANY NY PEST,22 Kairnes Street,Albany,NY,12205,518-464-4002,518-452-2194

Servicing Branch	3056	Contract Number	P136576421
Customer	1400 WASHINGTON AVE, MAIN CC	Premise Number	15
	KIT & SERERY	Visit Type	SERVICE MAINTENANCE
	1400 WASHINGTON AVE	Visit Date	08/22/2025
	ALBANY		
	NY		
	12222-0100

Order Number	Status	Service Date	Report Description
36275888		08/22/2025	FLY - INSECT TRAP MAINTENANCE
36275890		08/22/2025	GENERAL PEST CONTROL - MAINTENANCE
36275892		08/22/2025	BIOREMEDIATION ONGOING FULL SERVICE MAINTENANCE

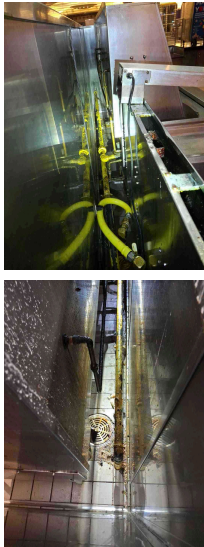
Date	Location	Recommendation: Type/details	Recommendation Image
07/18/2025 Reference: 152	Building: Univ Auxillary CC Main Kitchen Floor: Main Zone: Main Kitchen Location Area: Internal Location: Main Kitchen	Status:NEW Type: Sanitation Responsibility: An accumulation of food product from damaged goods noted. Please remove food product to prevent attraction by pests. Behind friers in Calypso.

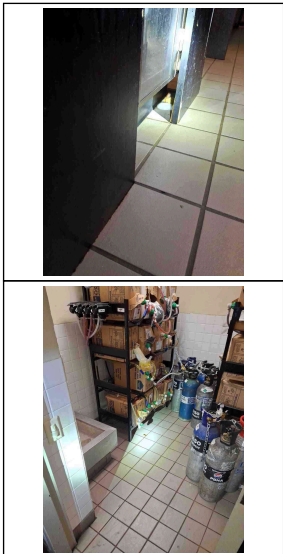
Reference: 149

An accumulation of non-food product from damaged goods noted. Please remove product to prevent attraction by pests. Syrup leaking.

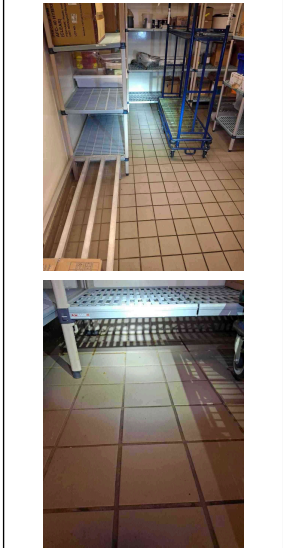
Reference: 148

An accumulation of food product from damaged goods noted. Please remove food product to prevent attraction by pests. Under back shelves.

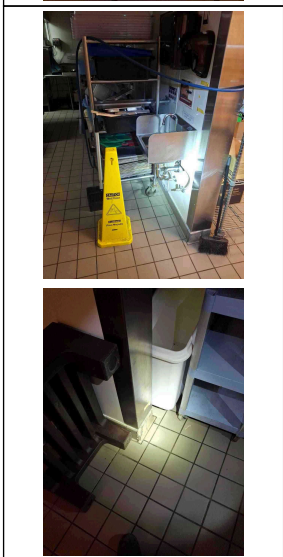
Reference: 147

Cracks or damage to wall allowing pest access. Please repair to prevent pest entry.

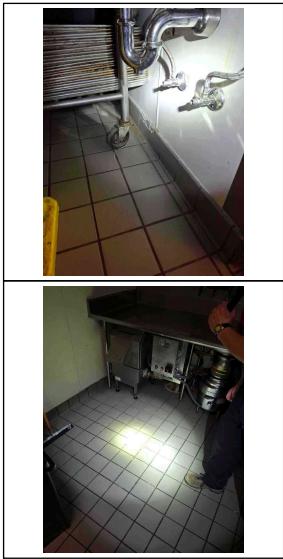
Status:NEW
Type: Structural
Responsibility:
Water leak/standing water inside. Please remove water and repair leak to prevent unsanitary conditions and attraction by pests. Please utilize fans to dry floors overnight. By garbage disposal.
